# Volume IV Appendix F.5

## Space Shuttle STS-107 Columbia Accident Investigation, External Tank Working Group Final Report – Volume 1

This report summarizes the results of the analysis, design, production, and performance of External Tank (ET-93), performed by the External Tank (ET) Working Group (ETWG), as part of the STS-107 *Columbia* Accident Investigation.

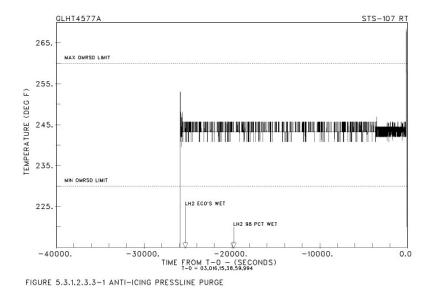
Figure 5.3.1.2.3.3-1. Anti-Icing Pressline Purge

Heater outlet temperature data for the anti-icing purge flow are presented in Figure 5.3.1.2.3.3-1. These data are shown in comparison with the OMRSD limits with select loading events identified on the time scale and indicate that, except for the shutdown transient, the anti-icing purge supply temperature was within specified OMRSD requirements throughout the pre-launch operations.

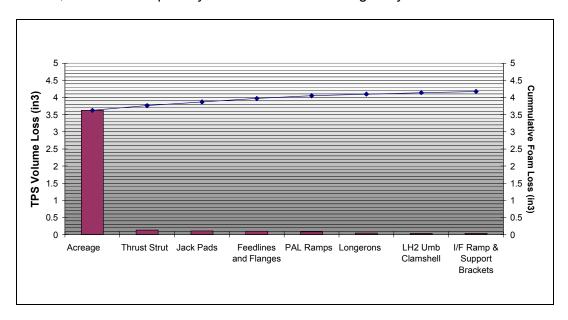
Figure 5.3.2.2-1. Areas of Observed Loss

Of the 113 Space Shuttle flights, 79 flights had useable imagery of the +Z axis from these cameras. The data collected during the STS-107 accident investigation were aggregated into major areas of TPS loss (Volume III). TPS loss has been observed on 82% of the missions with useable imagery. Areas of observed loss are shown in Figure 5.3.2.2-1. Recent material changes and configuration changes were also reviewed in an attempt to further assess TPS loss. Foam loss over time is shown in Figure 5.3.2.2-2. The loss of acreage TPS is primarily related to an increase in intertank acreage TPS loss attributed to a recent material change (the blowing agent, HCFC 141b) in the intertank acreage TPS. The TPS loss phenomenon observed since this material change was subsequently mitigated through venting of the TPS to allow entrapped pressure to outgas. Although intertank TPS loss, through 'popcorn-type' divots, still occurs, the size and quantity of the divots has been greatly reduced.

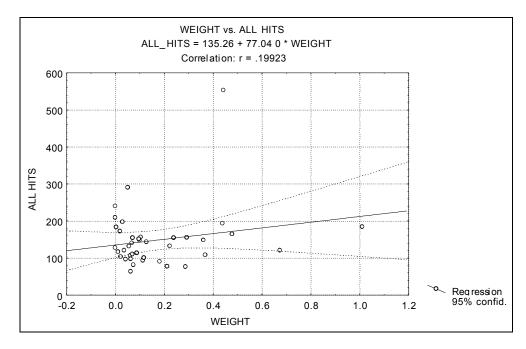
Figure 5.3.2.2-5. Correlation of Visible Foam Loss to Orbiter Damage

Foam loss data from the bipod ramp, flange, LO2 tank, Intertank, and LH2 tank were used in the analysis. Using all observed foam loss and Orbiter data correlated to this set of missions, there were no significant pair-wise correlations between foam loss and Orbiter hits. The regression chart of TPS loss weight versus tile damage is shown in Figure 5.3.2.2-4. Analyses of those missions that only assess missions with observable loss, however, indicate a slight correlation. None are statistically significant at the standard p = 0.05 level. Significance is approached at the p = 0.10 level for volume versus hits >1 in. (p = 0.102), volume versus lower surface hits (p = 0.095), weight versus lower surface hits (p = 0.096), and weight versus lower surface hits >1 in. (p = 0.106). The associated regression chart for this case is shown in Figure 5.3.2.2-5.

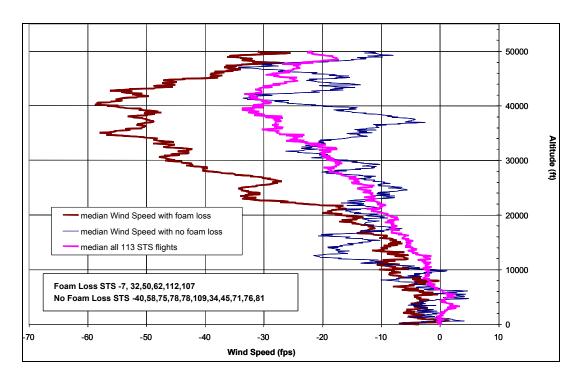
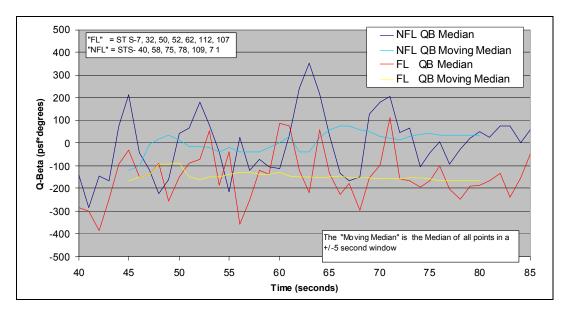
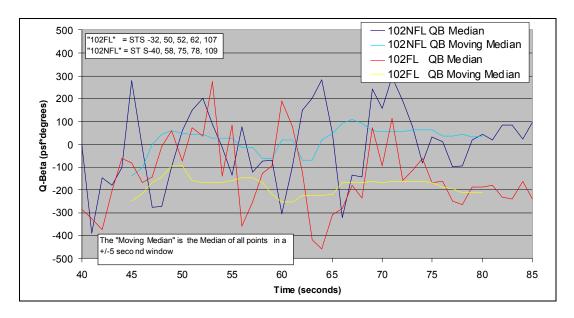
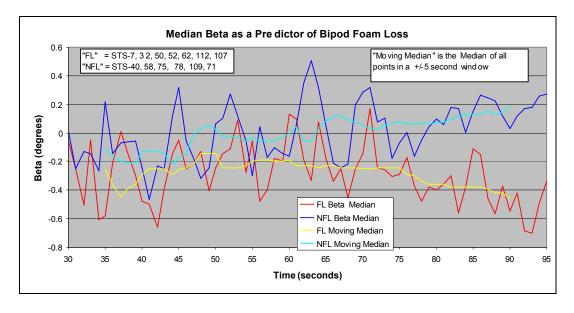
Sideslip angle, Q-beta and out-of-plane wind velocity showed a statistical correlation with regard to STS foam loss flights. Results are shown in Figures 5.3.3.4-1 through 5.3.3.4-4.

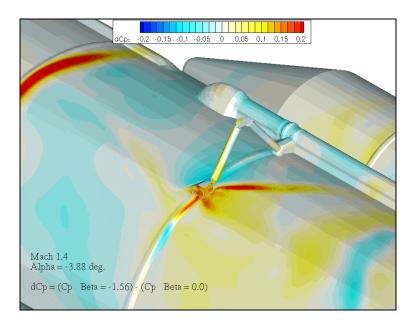
Figure 3.5.3.4-5. CFD Model of Bipod Region

Computational Fluid Dynamics (CFD) analysis of the LH bipod ramp shows that as Beta gets more negative (+2, 0, -1.56 deg), the axial, radial, and side forces on the Bipod Foam decrease for a constant alpha (-3.88 deg) and 1.4 Mach number. Shock loadings (impingements and movements) are extremely complex and very dependent on Mach Number, angle of attack ( $\alpha$ ), and angle of sideslip ( $\beta$ ). Also, the LOX feedline produces asymmetric flow (Figure 5.3.3.4-5). A recent updated CFD geometry/grid system to include intertank stringers, detailed +Y bipod ramp and feedline geometries was developed. Results confirmed that there are a number of differences between air loads at the two ramp locations. The +Y ramp side force is much less sensitive to sideslip/ $\beta$ :

- At Mach 1.40, the –Y radial load is more than double +Y load.
- At Mach 2.46, the –Y radial load is smaller than the +Y load.

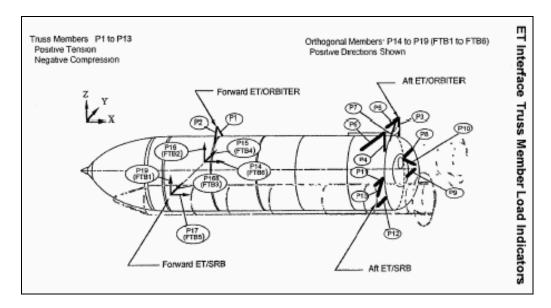
Figure 7.2.3.8.1.2-1. ET Strut Load Indicators

Figures 7.2.3.8.1.2-1 and 7.2.3.8.1.2-2 show the location of the load indicators evaluated with respect to the ET interfaces: truss members and interface load indicators. The Boeing analysis group, through the SSP loads board, provided the reconstructions to the Interface Team. The BET loads reconstruction was based on a rigid body analysis. In addition to the BET loads indicator sets, an additional flexible body reconstruction was provided.

No loads issues were found with any phase of operations. All indicators were well within design limits. The flex body loads reconstruction was actually less than the BET reconstruction, so they did not affect the evaluation. All of the analysis to date shows no evidence of excessive or anomalous loading.
